[LANCIA](#) / [YPSILON](#) / [1.3 JTD](#) / [PROCEDURES](#) / [70 FITTINGS](#) / [7005 PASSENGER COMPARTMENT FRONT SIDE DOORS](#)

/ 7005M28 FRONT SIDE DOOR ELECTRICALLY OPERATED WINDOW MOTOR - R R WITH DOOR PANEL-MOUNT FRAME REMOVED

2429514 - 7005M28 front side door electrically operated window motor - r r with door panel-mount frame removed

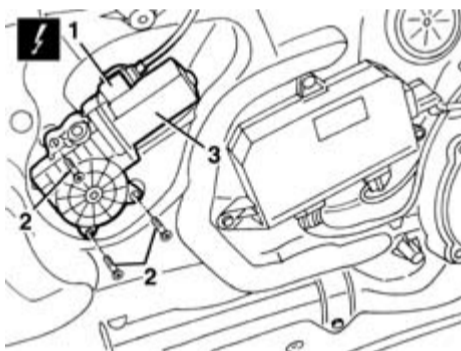
1. Disconnect the electric window motor connection.

2. Undo the bolts.

3. Remove the motor releasing the splined shaft.

Check that the motor is undamaged.

Connect the electrical connection.

Position the motor and secure with bolts.
