[LANCIA](#) / [YPSILON](#) / [1.3 JTD](#) / [PROCEDURES](#) / [70 FITTINGS](#) / [7005 PASSENGER COMPARTMENT FRONT SIDE DOORS](#)
/ [7005E FRONT SIDE DOOR TRIM](#) / 7005E12 CORNER COVER OF ONE FRONT SIDE DOOR, LH OR RH R R

2429507 - 7005E12 corner cover of one front side door, lh or rh r r

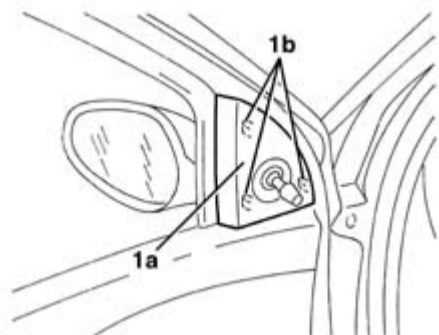
1. Release the trim (1a) releasing the retainers (1b).

Check that the trim and the retainers are not damaged.

Fit the trim attaching the retainers.
