[LANCIA](#) / [YPSILON](#) / [1.3 JTD](#) / [PROCEDURES](#) / [70 FITTINGS](#) / [7005 PASSENGER COMPARTMENT FRONT SIDE DOORS](#)
/ [7005M FRONT ELECTRIC WINDOWS](#)

/ 7005M27 ELECTRIC 'WINDOW OPENING MECHANISM FOR ONE FRONT DOOR, LEFT OR RIGHT - R.R. WIWTH SUPPORT FRAME REMOVED

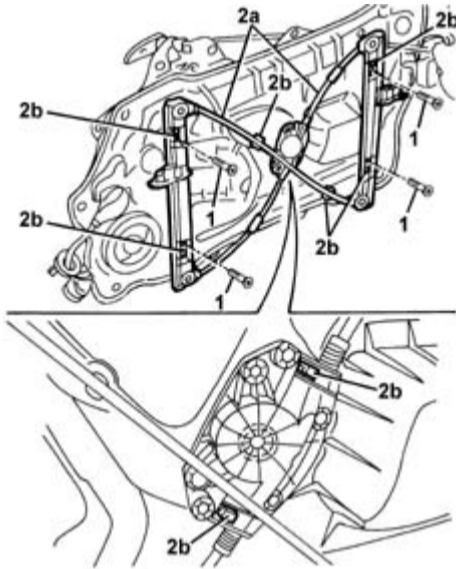
1. Undo the bolts.
2. Remove the mechanism (2a) releasing it from the retainers/centering devices (2b).

Check that the mechanism is not damaged.

Positin the mechanism and attach it to the retainers/centering devices.

Tighten the bolts.
