[LANCIA](#) / [YPSILON](#) / [1.3 JTD](#) / [PROCEDURES](#) / [72 PANELS AND FRAME](#) / [7205 STRIPPING FOR REPLACEMENT OPERATIONS](#)
/ [7205E EXTERIOR PARTS](#) / 7205E37 STRIPPING FRONT SIDE DOOR INNER SUPPORT FRAME

2429708 - 7205E37 STRIPPING FRONT SIDE DOOR INNER SUPPORT FRAME

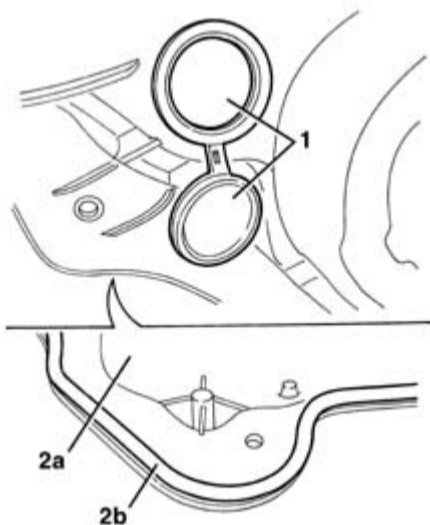
1. Prise up both covers
2. Recover the frame (2a) with gasket (2b).
